CRS - Color Variant (WHITE)
1500 Hours ASTM B117 Salt Spray

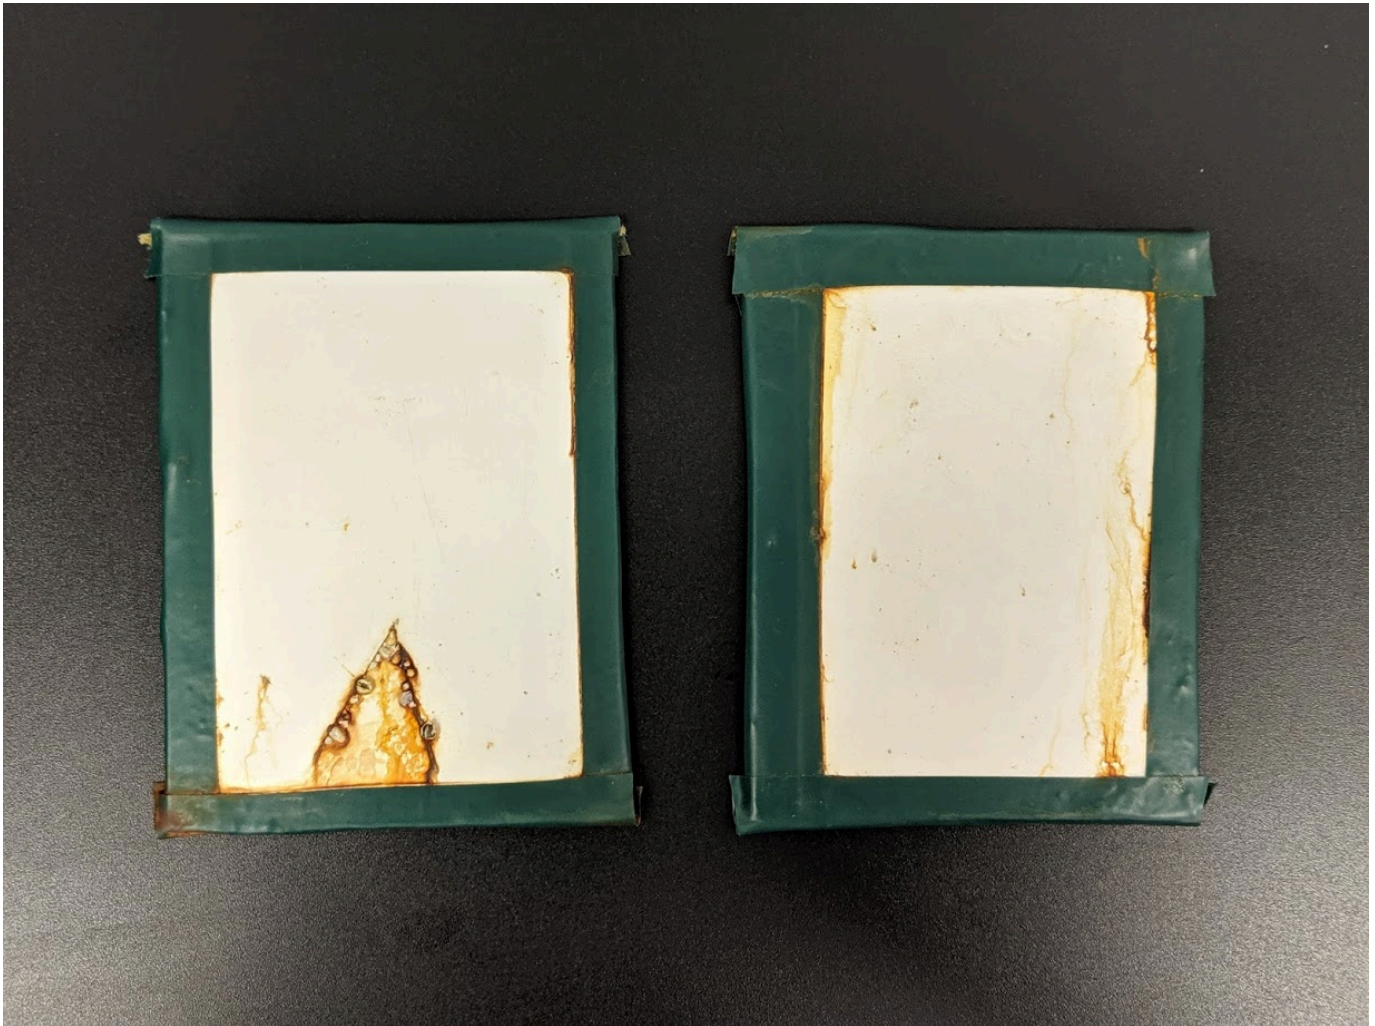
Left: Scribed panel shows bubbling and rust development in and around immediate area of scribe (V shape). No rust migration under coating, no peeling, coating stays in tact.

Right: Non-scribed panel. No signs of failure. Taped edges allowed some rust from uncoated edges to bleed through the tape. Coating shows no signs of failure.
